# Hunters Point Naval Shipyard Environmental Program Fieldwork Update

## Hunters Point Shipyard Citizens Advisory Committee Environmental & Reuse Subcommittee

February 22, 2021

Hunters Point Naval Shipyard  
Navy Base Realignment and Closure (BRAC)

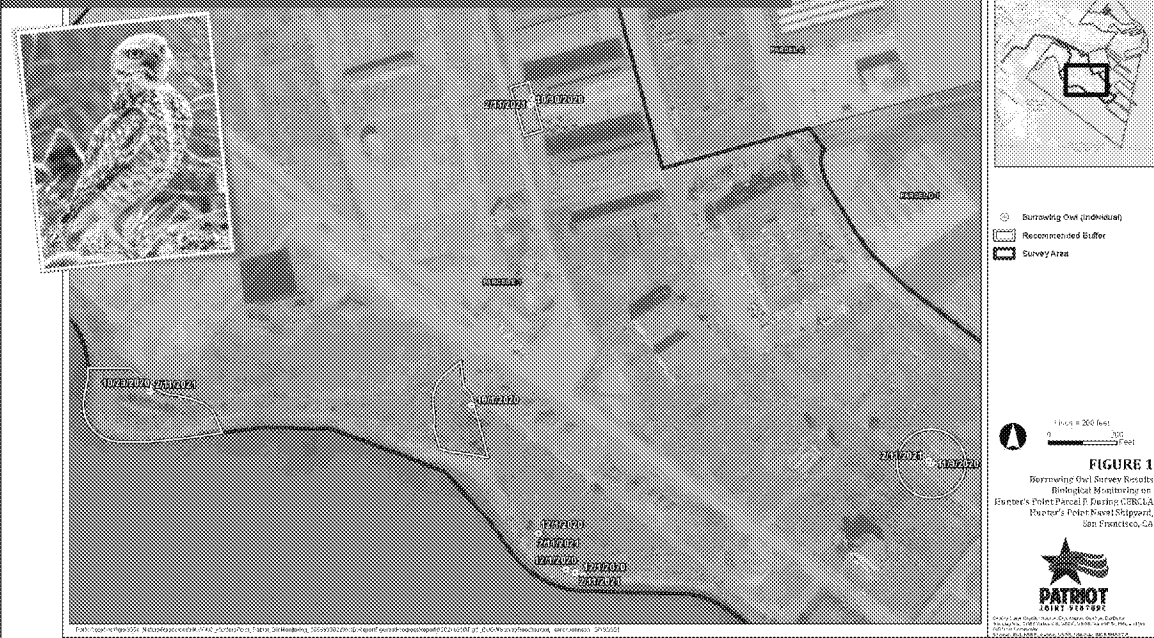
## Parcel E: IR-03 Burrowing Owl Locations

Environmental stewardship is a crucial component of all of our activities at HPNS. We work closely with a biomonitoring contractor to ensure that all species are protected during cleanup. Here you see a map of burrowing owl locations in Parcel E. All of contractors are prepped to avoid impacting native species. We recently relocated multiple owl burrows to ensure their safety

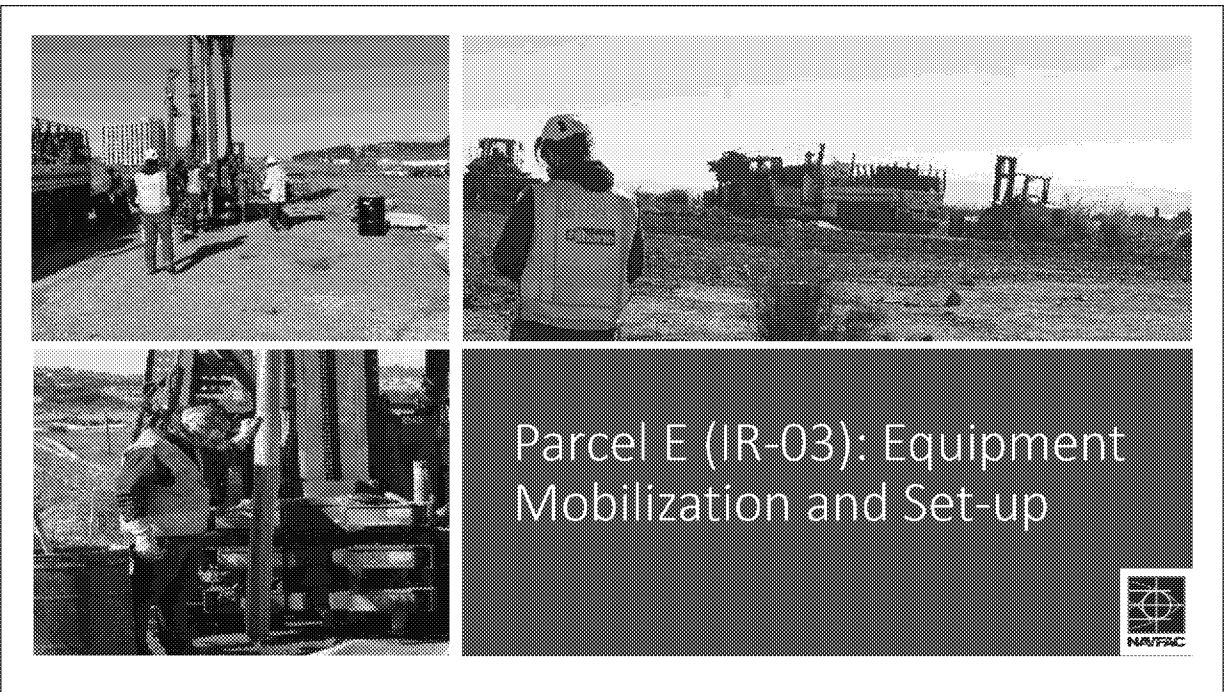
Here are some photos of the IR-03 fieldwork. Currently, the contractor is mobilizing and doing site preparation prior to other activities.

In these photos, you can see a drill rig prepping to construct the slurry wall. A crane will be installed in March, and excavations for the sheet pile wall are scheduled to begin in April.

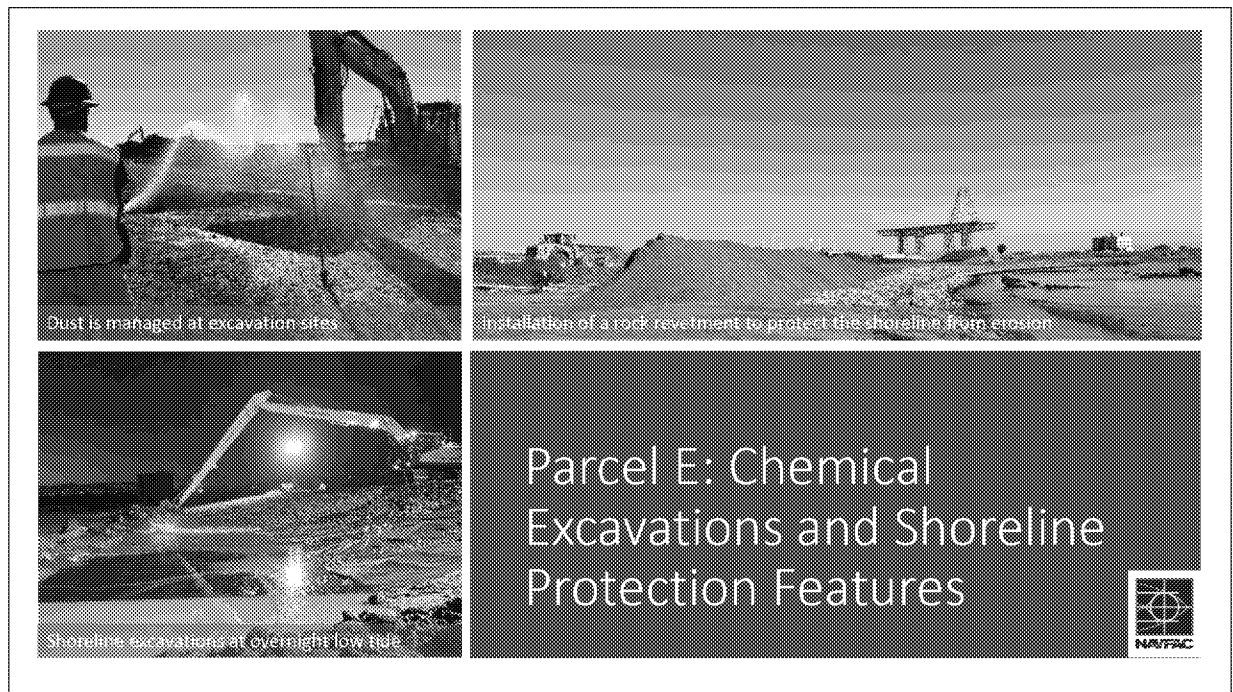
On this slide, we see photos of fieldwork outside of IR-03.

The top-left photo shows our crew assisting with dust prevention procedures.

The image on the right depicts the installation of one of our shoreline protective features.

The photo on the bottom-left conveys one of the more difficult aspects of the project, which is working on the shoreline. Our contractors have been working around the tidal schedule to ensure that excavation activities can be conducted safely at no risk to workers, or the environment

Public interested in dust – adhere to approved work plans and regulatory standards by working in conjunction with our internal team, contractors and the regulatory agencies – examples of mitigation and monitoring - wetting, tackifier on soil and air monitoring stations

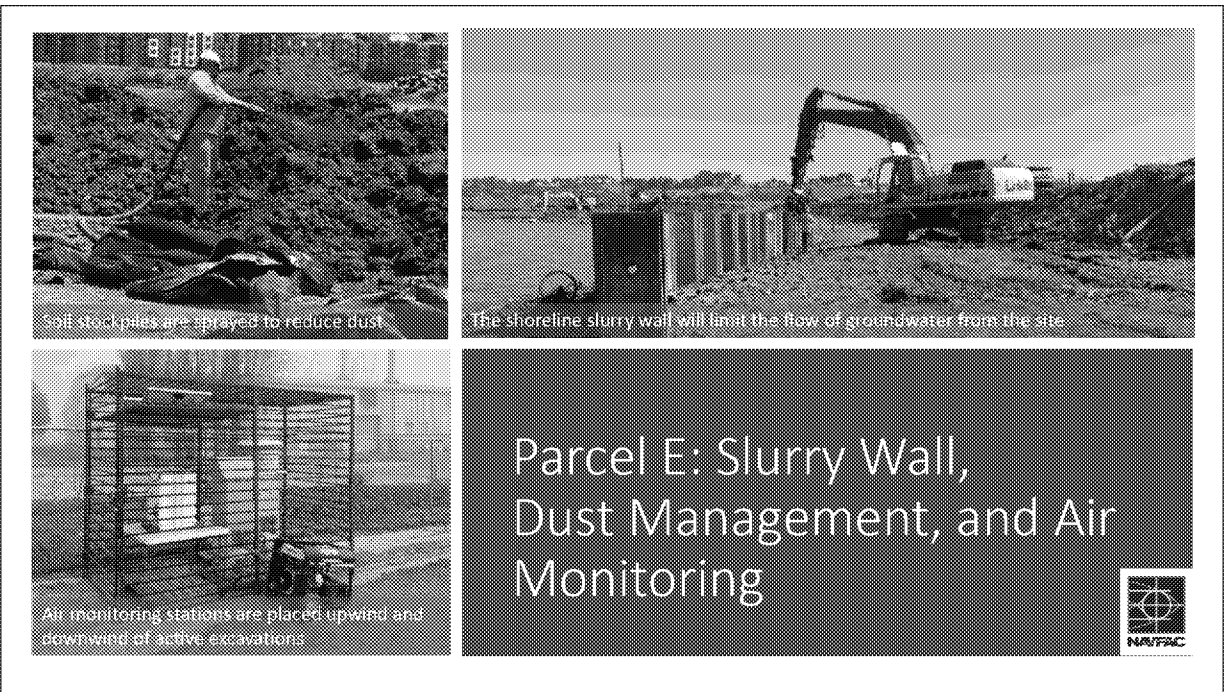
Other areas of Parcel E besides IR-3 (Ph1 and Ph3)

Dust management and air monitoring are a crucial component of all fieldwork at HPNS, as shown in the two photos on the left.

1. The top image shows a worker applying tackifier to the surface of the soil to prevent dust release in windy conditions (sometimes referred to as "gorilla snot").
2. The picture on the bottom left shows one of our multiple air monitoring stations across HPNS, which ensure the safety of both workers and residents.
3. The picture to the top right shows the installation of a sheet pile wall prior to slurry wall construction. This protects the bay from any potential contamination. As noted above a similar installation will be occurring along the shoreline of the IR 03 site in March.

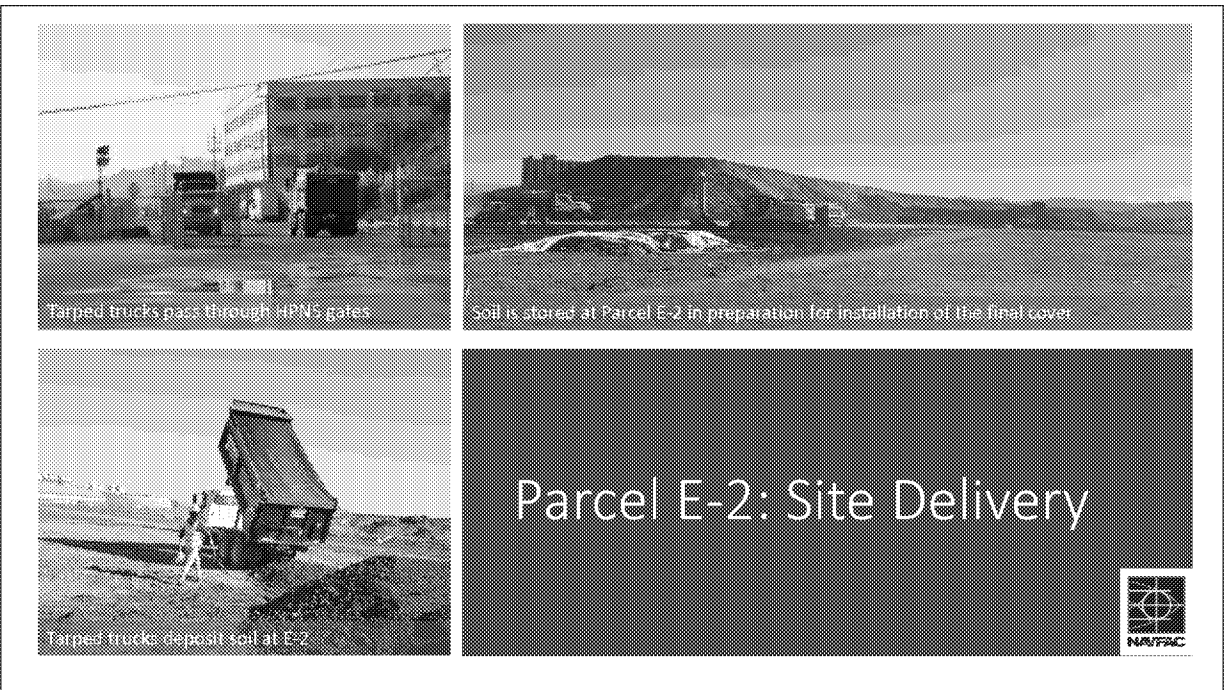
Top left: tarped trucks take soil from Parcel C (dock area) to Parcel E-2

Bottom left: tarped trucks tip soil on Parcel E-2 stockpile area

As can be seen in the image on the top right, a significant amount of soil has been delivered - more than 150,000 tons of soil to date! (estimate another 60,000 tons to still be delivered)

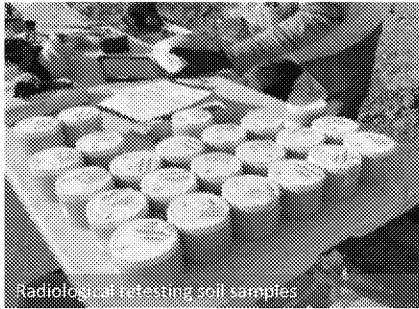
Radiological retesting soil samples

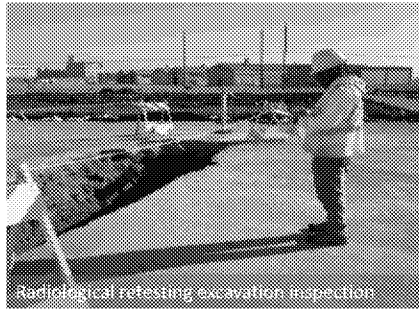
Radiological retesting excavation inspection
